Templeton-Whitney Grazing Allotments, Golden Trout Wilderness

Head Cut and Photo Point Monitoring, 2003 and 2010 (DRAFT)

By: Casey Shannon, Hydrologic Technician

Inyo National Forest, Supervisor's Office

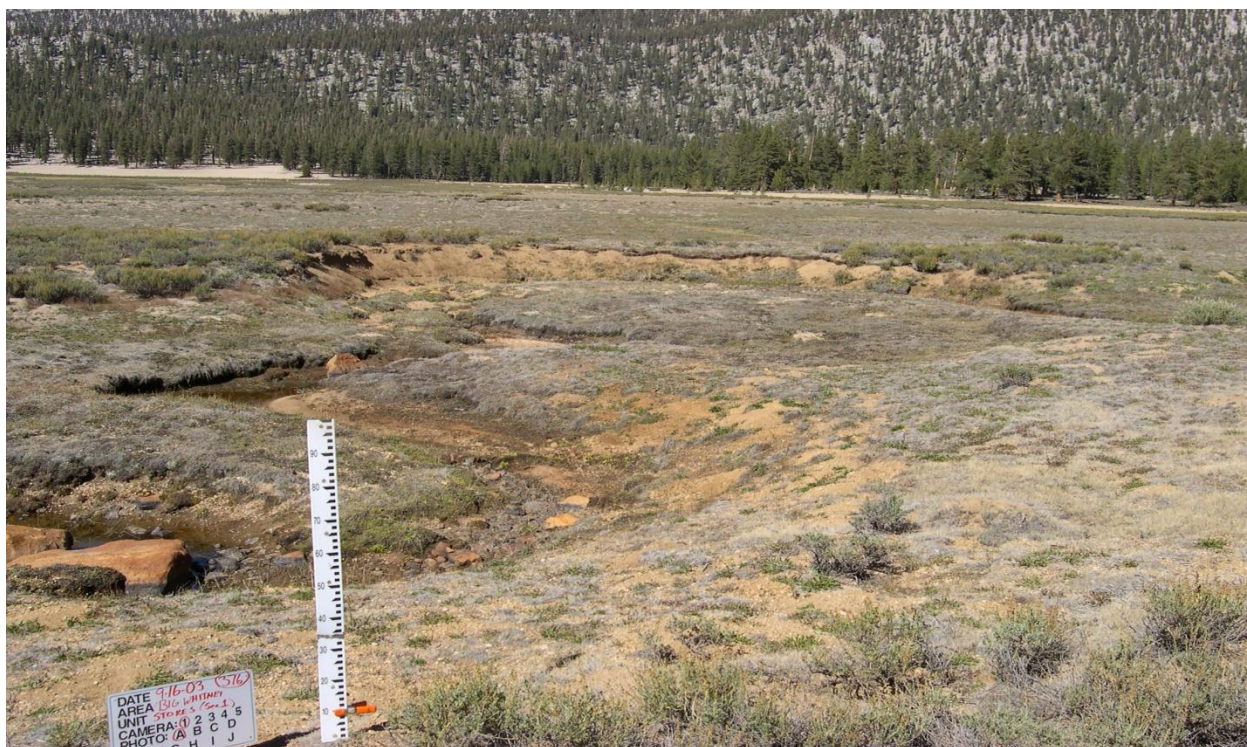
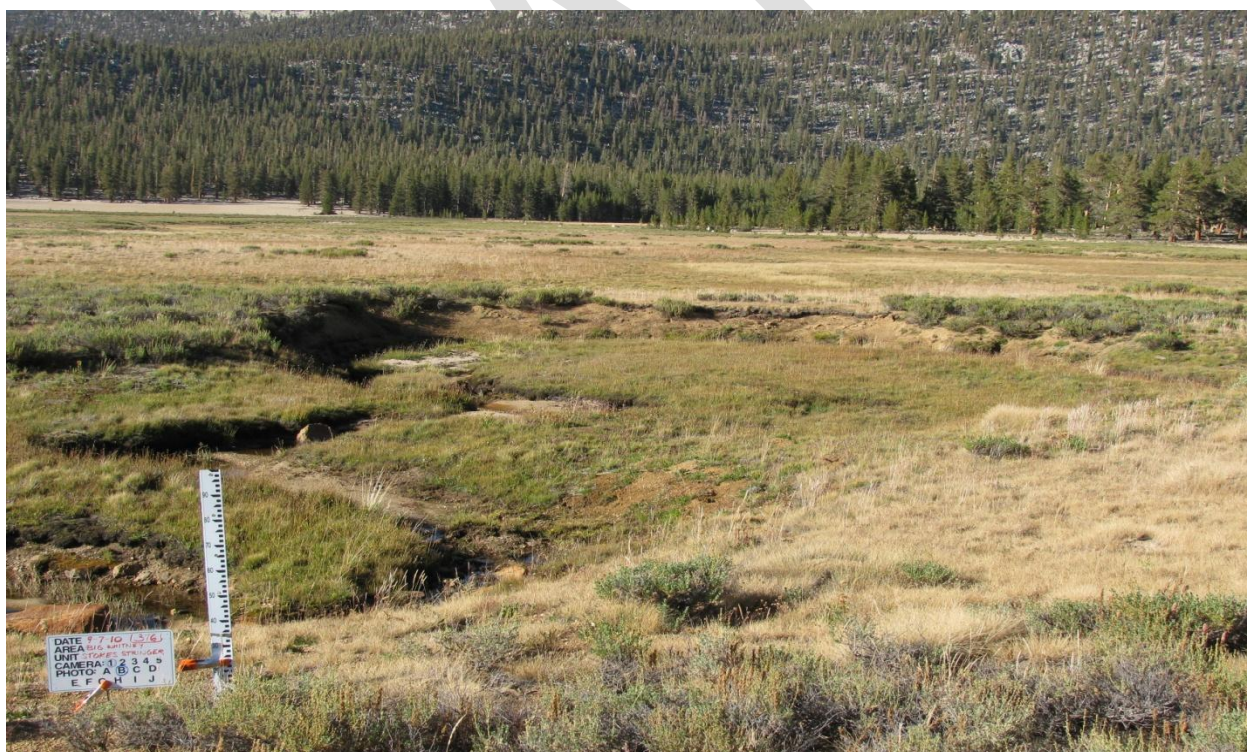
Above photo: Photo point 376 (PP 376) Stokes Stringer Section 1, September 2003. The terrace banks and floodplain within the channel are degraded with large areas of bare soil. **Below photo:** PP 376 photo retaken September 2010. Floodplain in channel bottom has moderately increased vegetation and terrace banks have slightly improved with vegetative cover and are still vulnerable to erosion. Stream channel is starting to set meanders with slightly improved bank stability. Thin organic horizon exists at this site, conducive to erosion.

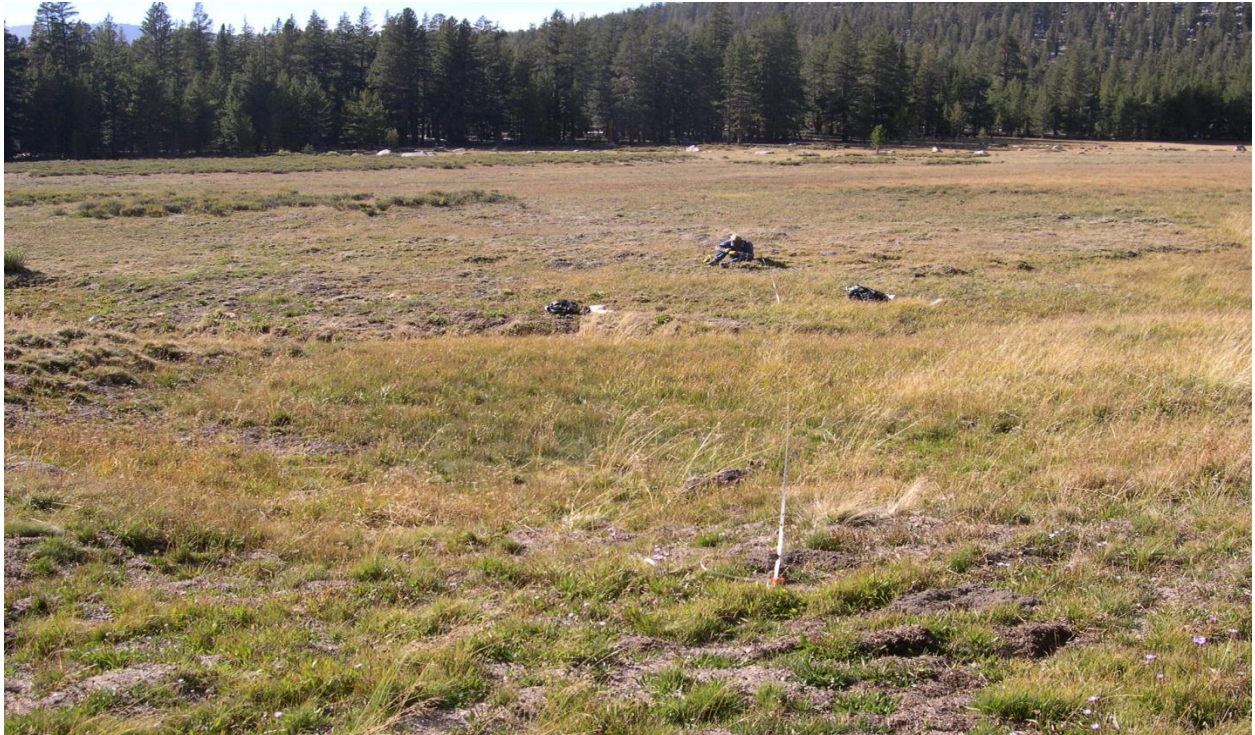
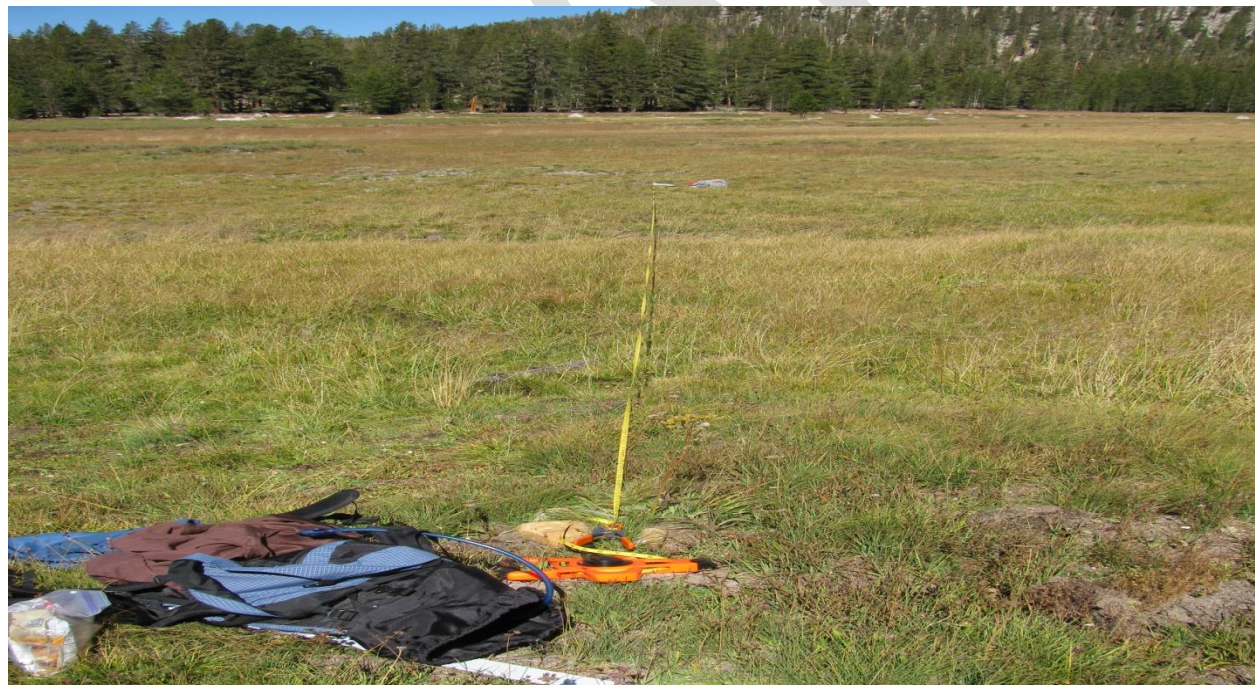
Above photo: Head cut 377 (HC 377) Stokes Stringer Section 2, September 2003. Looking across transect to north. Vegetation cover is weaker at this time and moderate amounts of bare ground are noticeable. **Below photo:** HC 377 Stokes Stringer Section 2 photo was retaken September 2010. Vegetative cover has increased and less bare soil is apparent. HC has migrated 19.5 meters upstream and a secondary active HC is found 13 meters above current location of HC 377. Thin organic horizon, shallow rooting depth and sandy surface soil may aid in headcut migration.

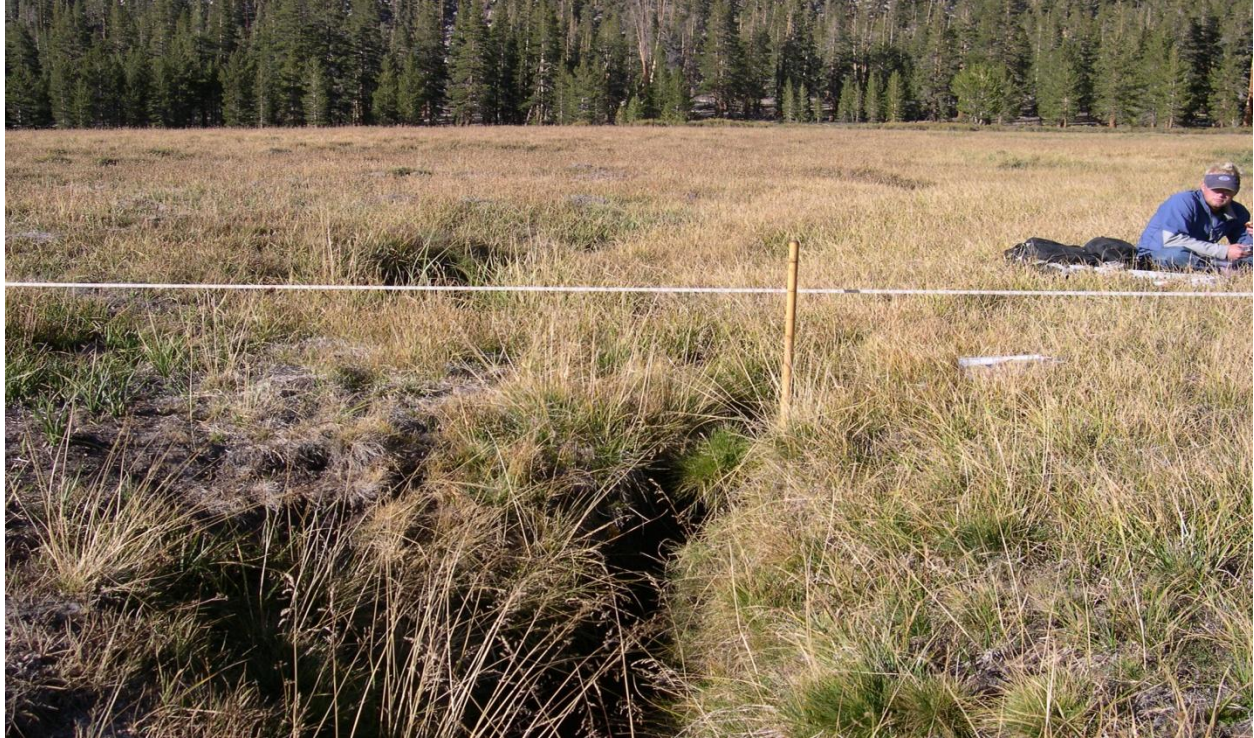
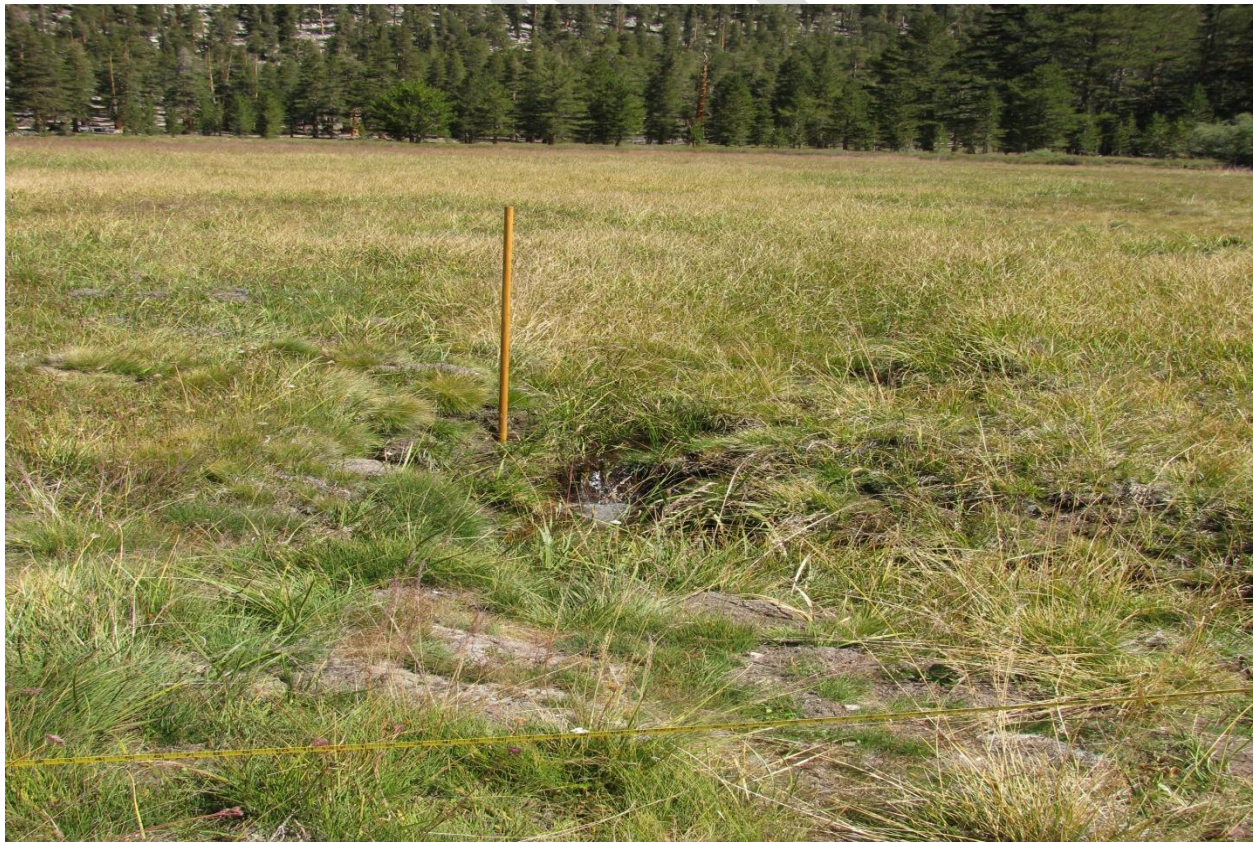
Above photo: Head cut 378 (HC 378) Stokes Stringer Section 2, September 2003. **Below photo:** HC 378 Stokes Stringer section 2, retake of photo September 2010. HC has migrated 3.60 meters since 2003, organic horizon and rooted vegetation at this site is deeper and tends to resist erosion during high flows.

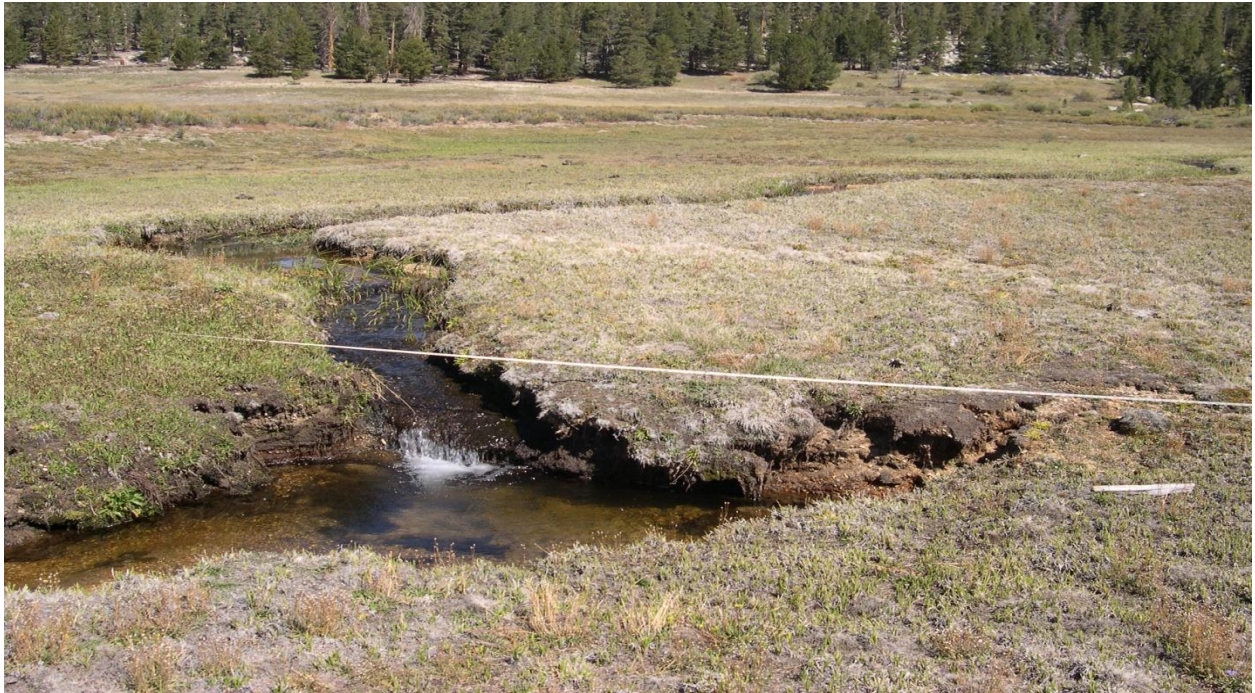
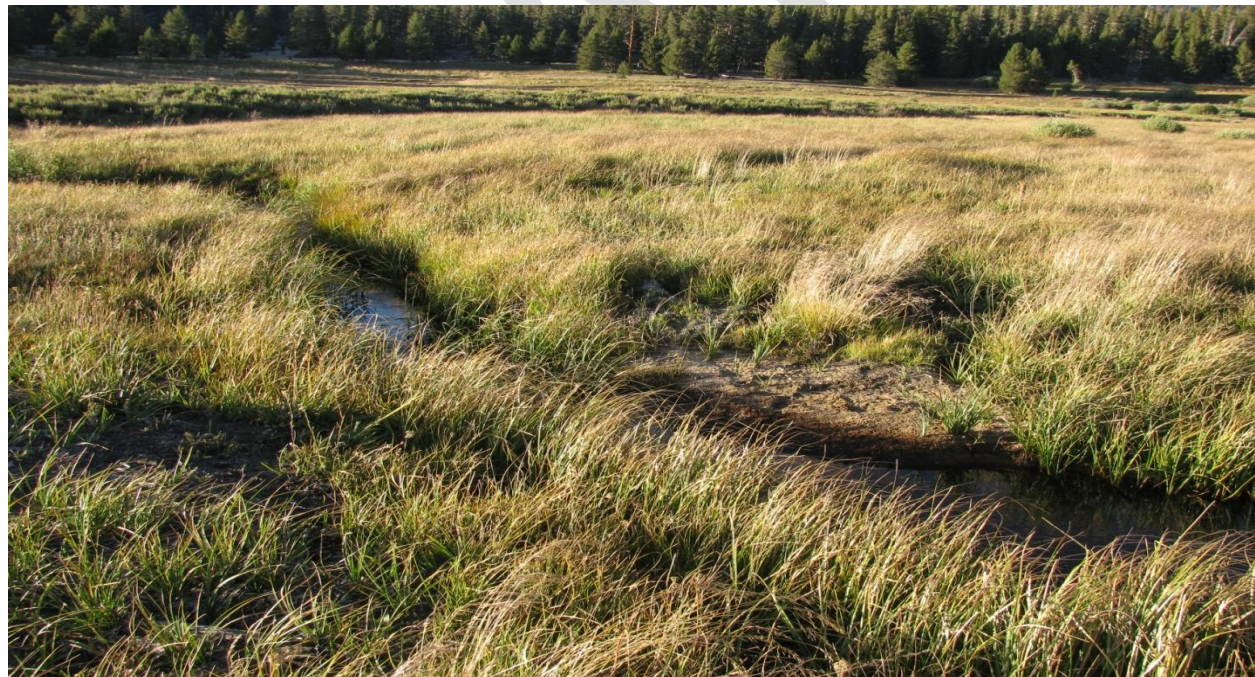
Above photo: Head cut 380 (HC 380) Big Whitney Meadow Section 2, September 2003. AKA PP taken in 1999. Active head cut in channel, riparian vegetation is thin and bare ground exposed. **Below photo:** HC 380 Big Whitney Meadow Section 2, photo re taken September 2010. Channel has filled with deposition from uplands above meadow and re-directed stream flow to another path. Widespread organic/silt deposition was found over entire site, a small remnant of the previous head cut found in 1999 is left upstream of the previous location approximately 20 meters. Vegetation productivity has significantly increased since 2003 and the meadow has a new floodplain. HC monuments set in 2003 were not relocated for measurements due to the large volumes of deposition at the site.

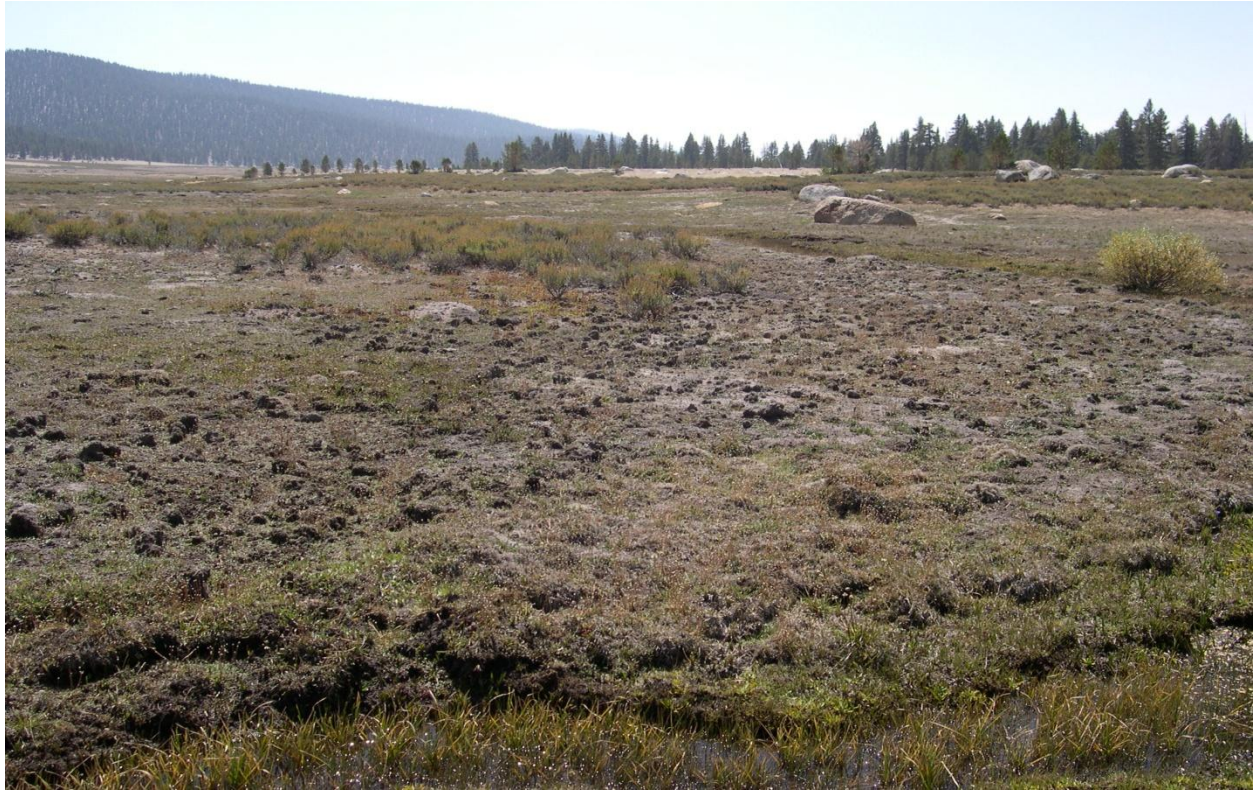
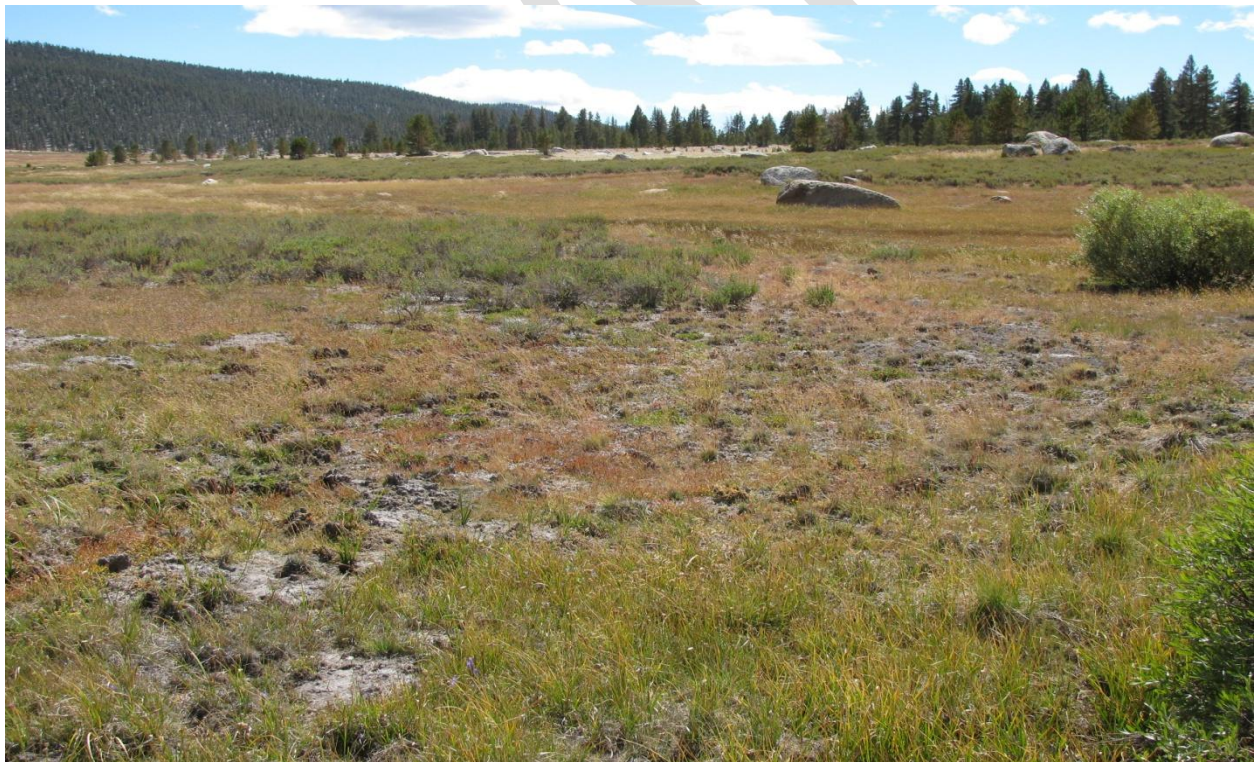
Above photo: Photo point 381 (PP 381) Big Whitney Meadow Section 2, September 2003. A large area of fragmented sod and bare ground with weakly growing riparian vegetation exists. **Below photo:** PP 381 Big Whitney Meadow Section 2, photo was re-taken September 2010. Riparian vegetation ground cover has moderately increased with areas of fragmented sod and bare ground still present. Site is still vulnerable to disturbance.

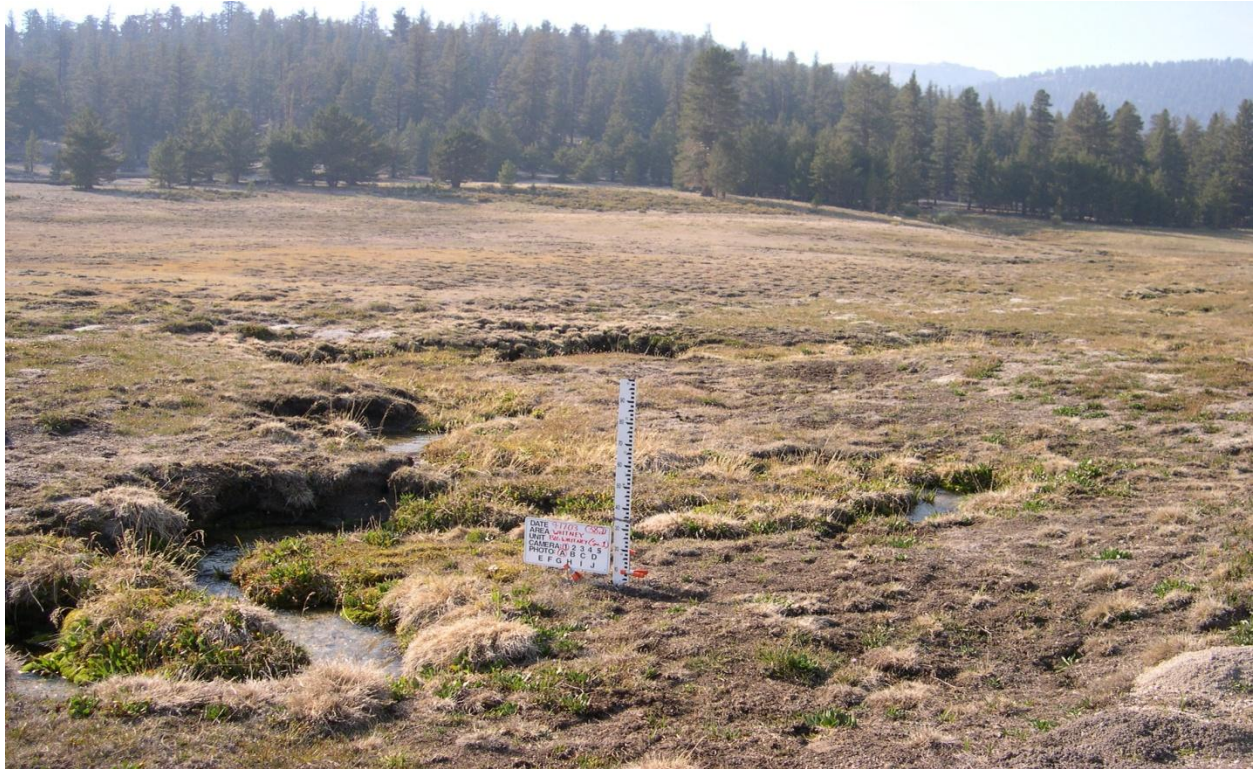
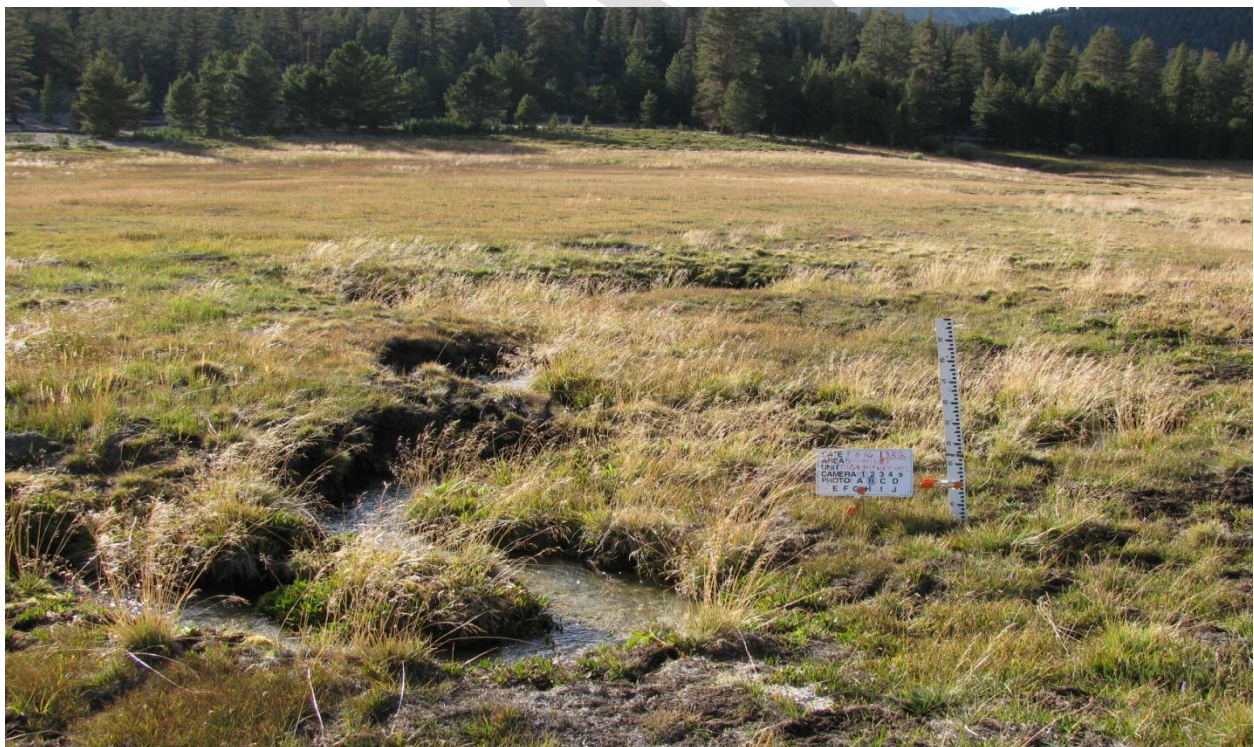
Above photo: Photo point 382 (PP 382) Big Whitney Meadow Section 1, September 2003. Hummocks are prevalent over the area, stream banks are mostly degraded and vegetative vigor is low. **Below photo:** PP 382 Big Whitney Meadow Section 1 photo retaken September 2010. Hummocks have started to diminish in form but still present. Stream banks are still unstable and degraded but with better vegetation. Floodplain vegetation overall has improved moderately at this site. Site is very wet and vulnerable to disturbance.

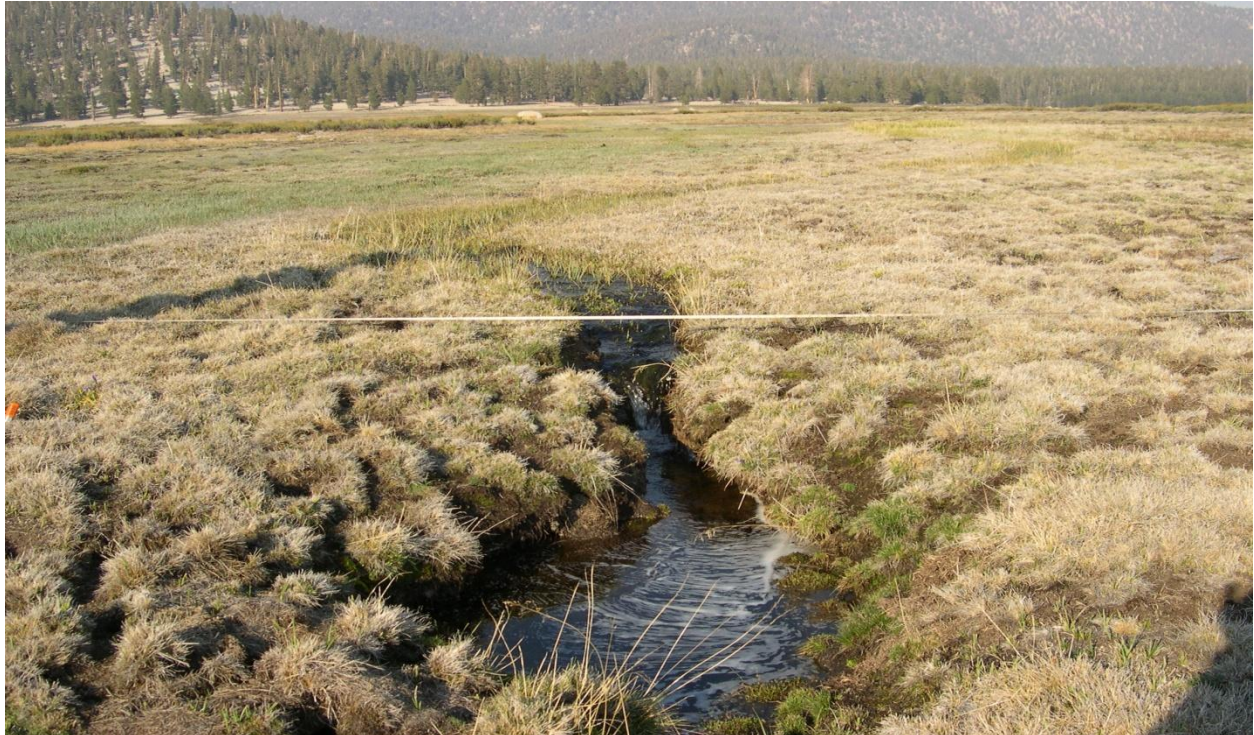
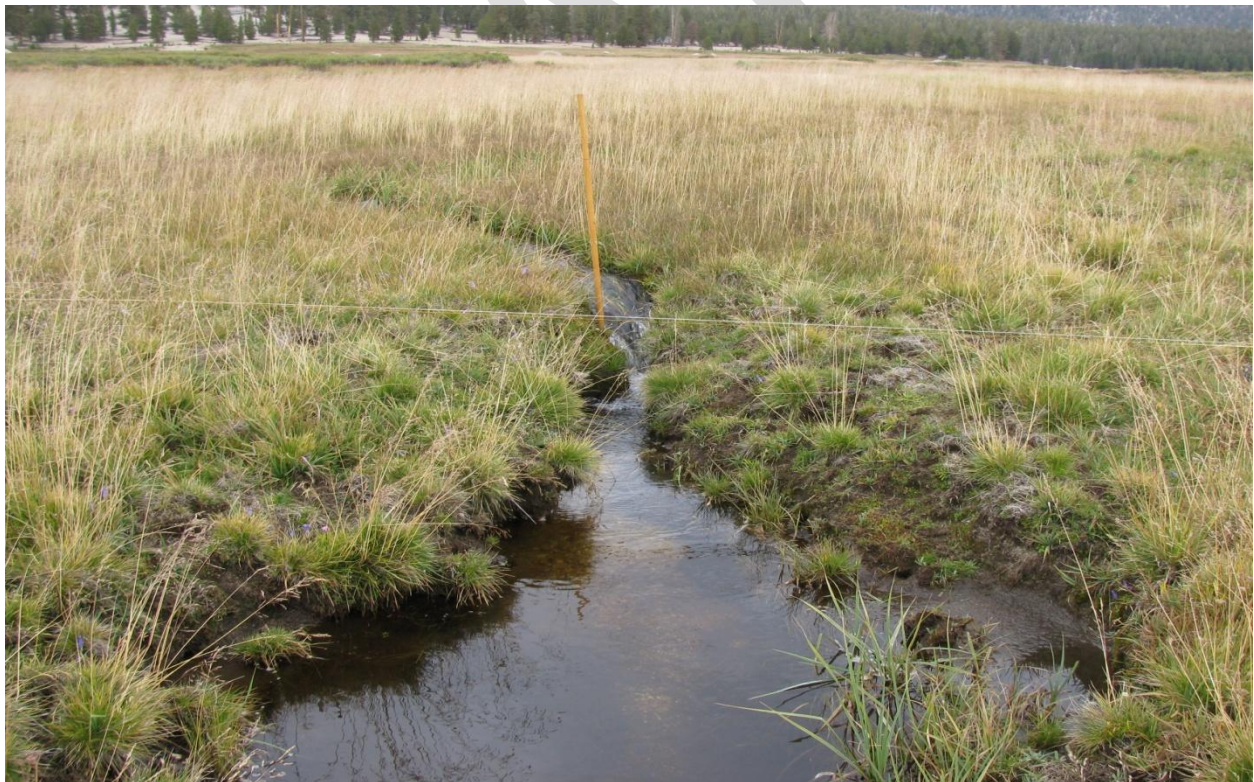
Above photo: Head cut 383 (HC 383) Big Whitney Meadow Section 1, September 2003. HC 383 is an active HC with eroded hummocks around site. **Below photo:** HC 383 Big Whitney Meadow Section 1 photo retaken September 2010. Head cut has migrated 1.07 meters since 2003, slow migration due to strong organic horizon and deep rooted vegetation at site. The site is very wet and vulnerable. Scour pool has increased in area since 2003. Hummocks are still present but starting to diminish, floodplain vegetation has increased.

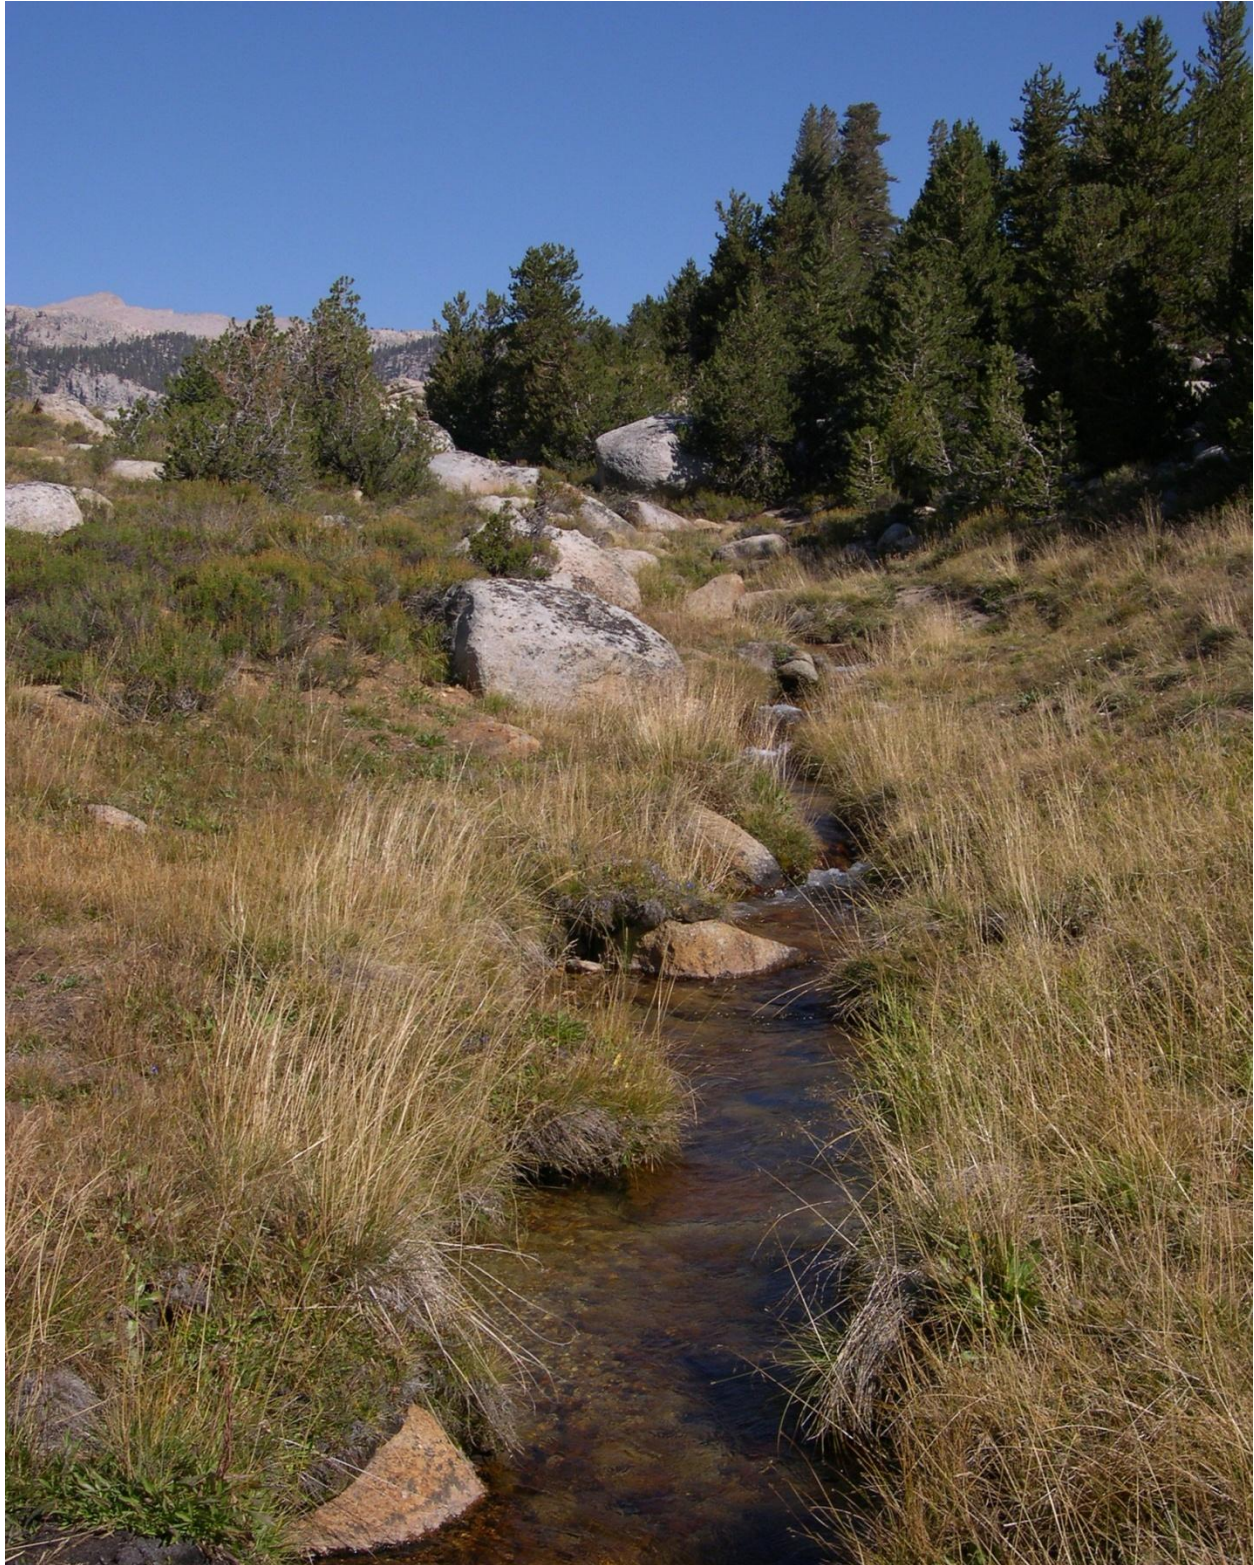
Photo: Golden Trout Creek lower end of Section 1 Big Whitney Meadow, September 2003. Stream banks stable due to large boulder component and strong vegetation. Moderate hummock formations found within seep areas near creek and small areas of bare ground. Another photo of this site was taken August, 1999. Photo on next page shows September 2010 retake.

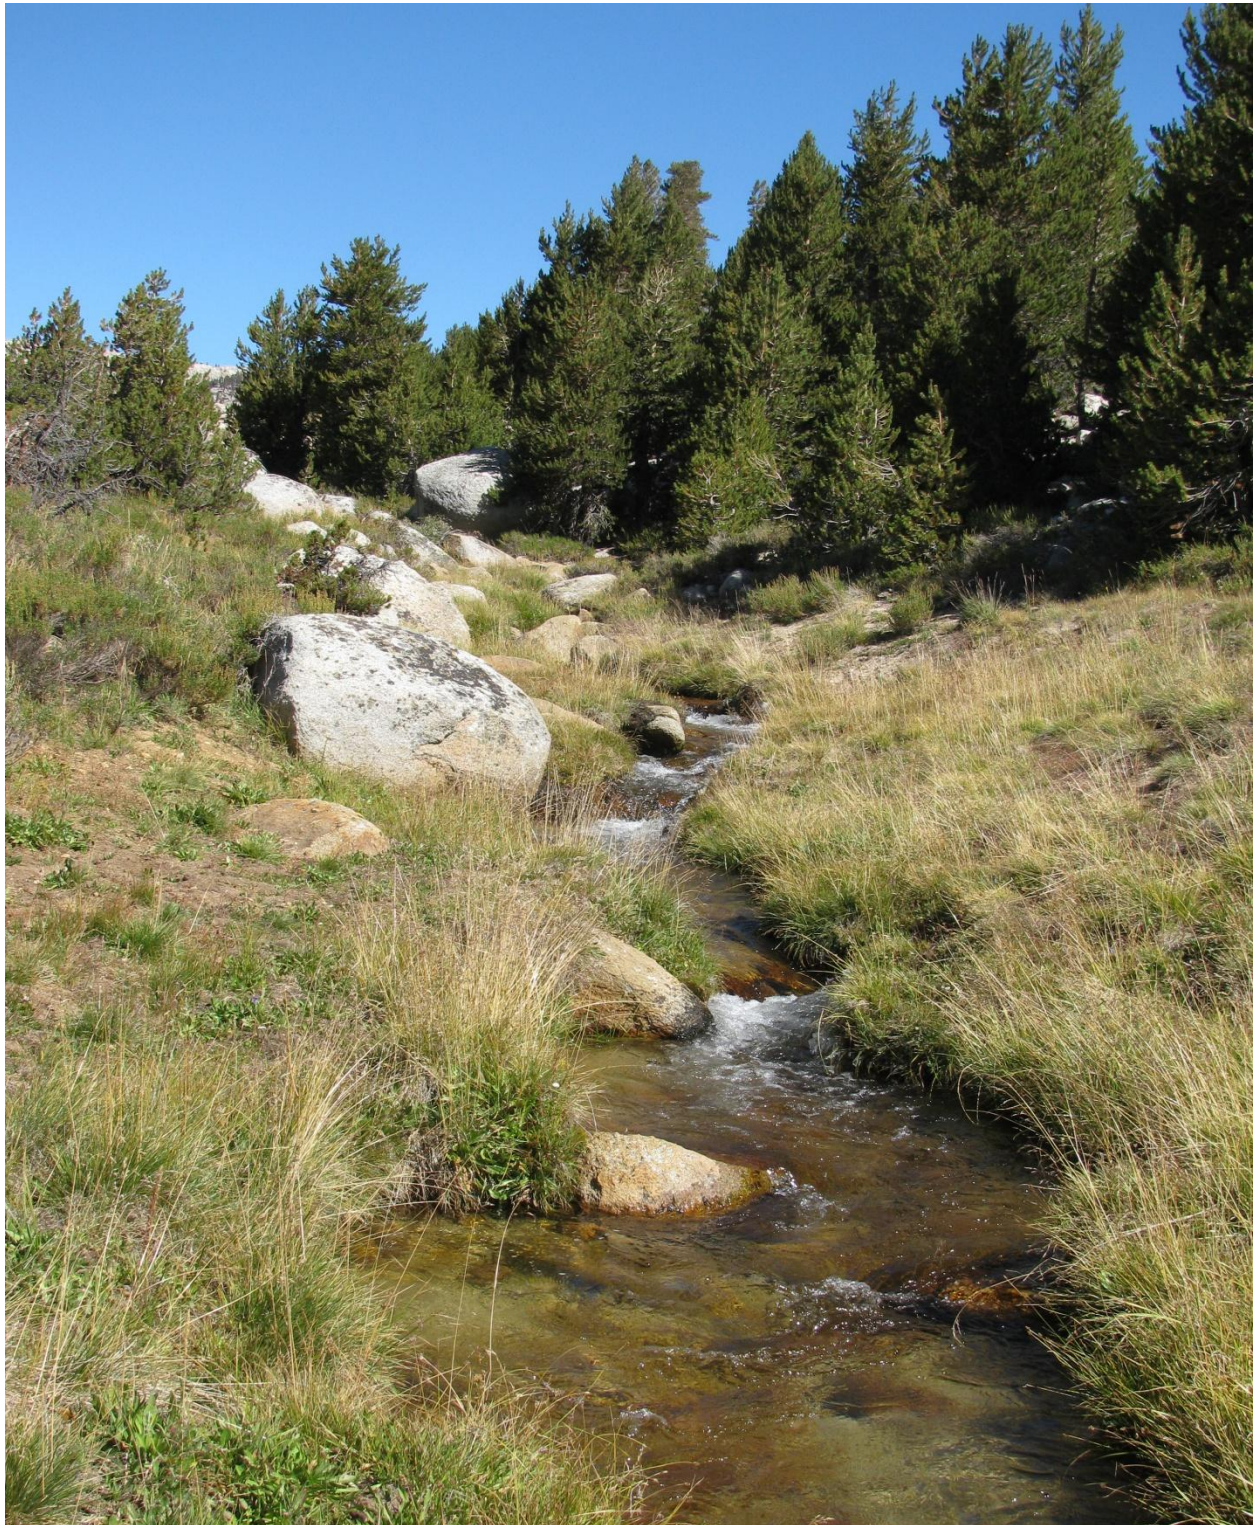
Photo: Golden Trout Creek lower Section 1 Big Whitney Meadow, September 2010. Little change since 2003, some increase of rodent activity on upper banks and disturbed soil. Stream flow is higher and water quality appears improved. Many golden trout seen along this reach.

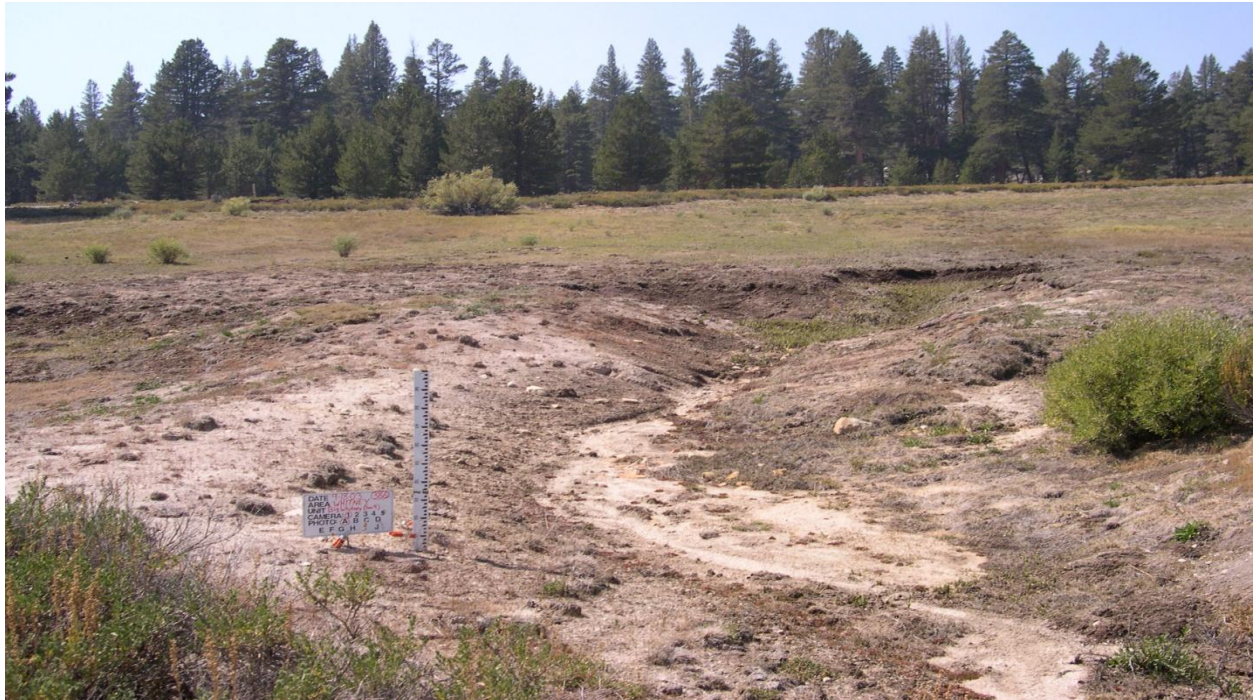
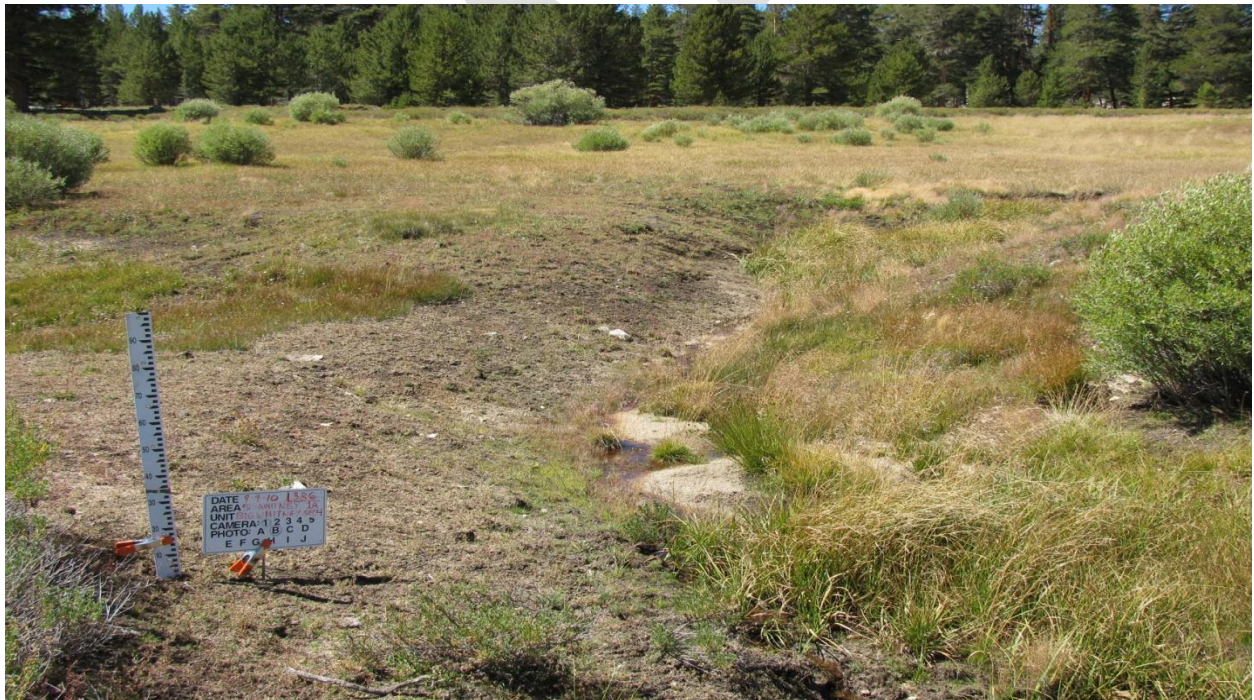
Above photo: Photo point 386 1A Big Whitney Meadow, September 2003. Site is a large area of bare ground, missing sod and eroded soil with a small barren head cut and gully. Vegetative cover is thin and weak.

Below photo: PP 386 1A Big Whitney Meadow Section 4, photo retaken September 2010. Vegetative cover has increased to a high percentage and the face of the head cut and gully has stabilized with new growth and is starting to aggrade. Willows have increased in numbers and vigor, and the water table has elevated. There is still a large area of erosion vulnerable bare ground at site.

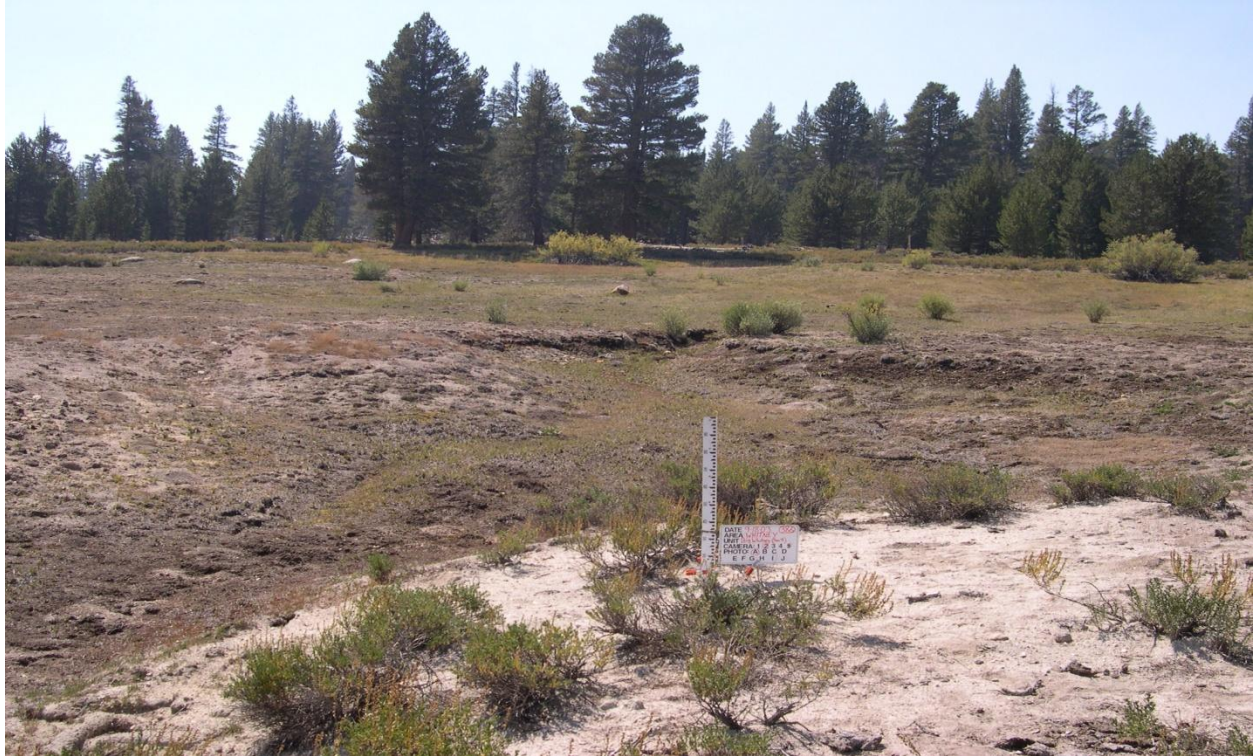
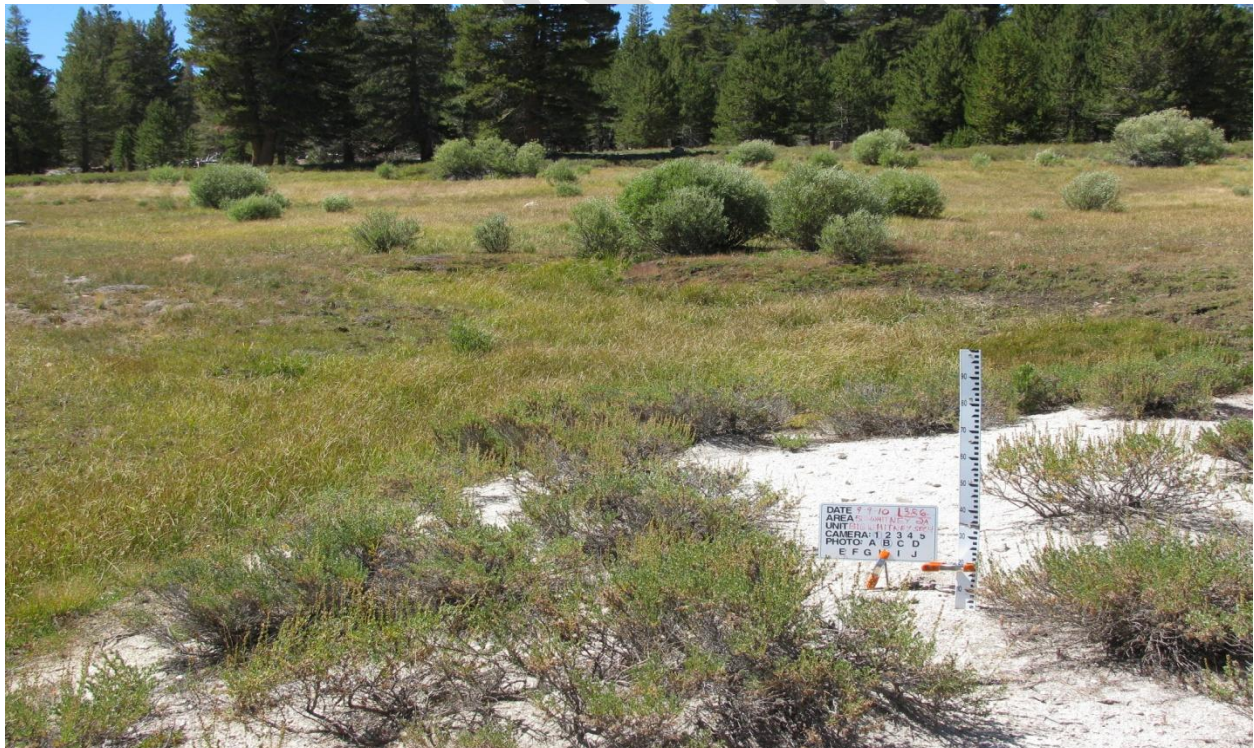
Above photo: Photo point 386 2A (PP 386 2A) Big Whitney Meadow Section 4, September 2003. Large area of bare ground and missing sod with active erosion and a large head cut and gully. Site is just adjacent to PP 386 1A to south. **Below photo:** Vegetation cover has increased significantly filling in and stabilizing barren gully and face of head cut, and gully has started to aggrade. Willow growth has increased and water table has elevated. There are still areas of bare ground to a lesser percentage than in 2003.
